**Proposed 110kV Substation and
Underground Grid Connection
at
Killoran, Co. Tipperary**

LISHEEN TMF ANNUAL REVIEW 2024

DATE: MARCH 2025

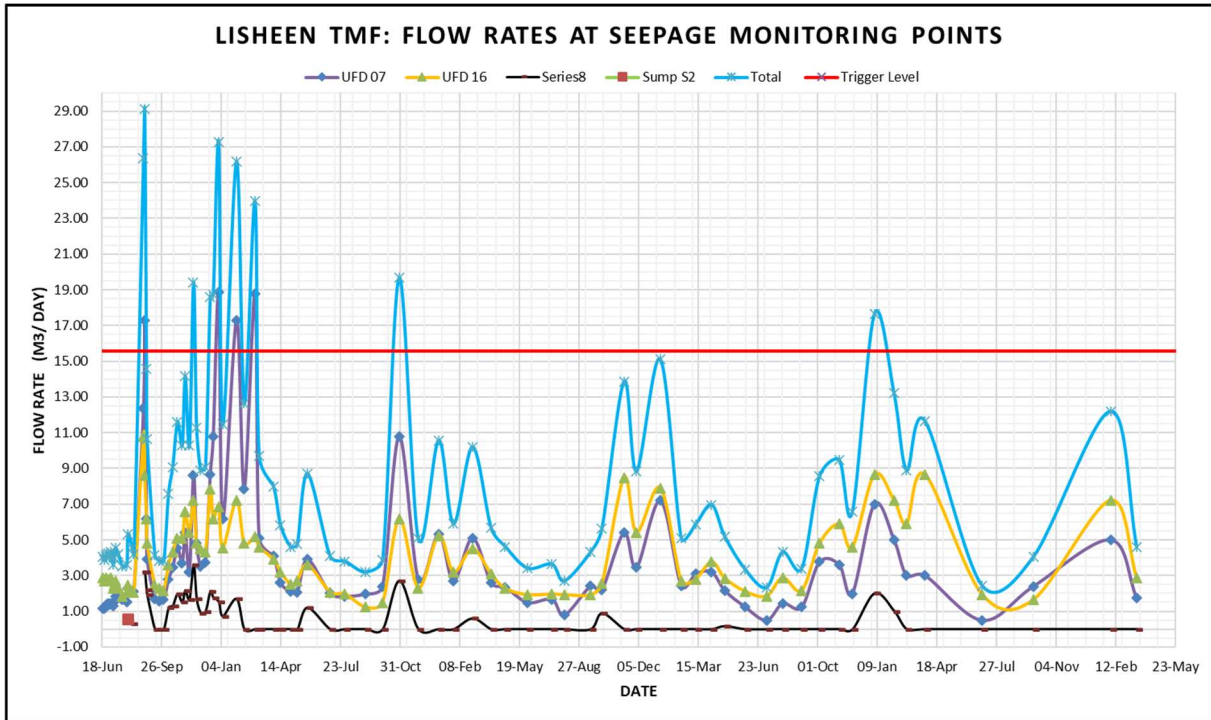
Figure 7-1 - Lisheen TMF - Seepage Flow Rates at UFD07, UFD14 and UFD16

- **Flow and Conductivity Measurements:**
Flow measurements at UFD07 and UFD16 consistently remained within the typical range of approximately 3–5 m³/day, while UFD14 recorded negligible flows under normal conditions. An isolated event in January 2024 registered a combined flow of 17.64 m³/day; however, corresponding conductivity readings remained below critical thresholds, indicating that the increased flow was due to rainwater dilution rather than an indication of increased leachate concentration.

During the reporting period, all measured seepage rates and conductivity values remained within Level 1 conditions, confirming that the drainage system—including the chimney/finger drain network and the supplementary weir installed in August 2022—is performing effectively.

The integrated monitoring data from Q1 2024 to Q1 2025 show that the seepage management system continues to function within safe parameters. The observed transient increases in flow rates during rainfall are effectively mitigated by the dilution effect, as evidenced by stable conductivity readings. It is recommended that the current monitoring regime be maintained and that further assessments be conducted following major rainfall events to ensure any transient anomalies are promptly addressed. In summary, the 2024–2025 data validate the ongoing stability and integrity of the TMF’s seepage management system, with all parameters remaining within the acceptable ALR thresholds

- Considering that flow measurement data has been identified as limited and is important for ongoing performance evaluation, it is recommended that flow meter(s) be installed to provide accurate and continuous flow data to support enhanced monitoring and informed decision-making regarding TMF management.

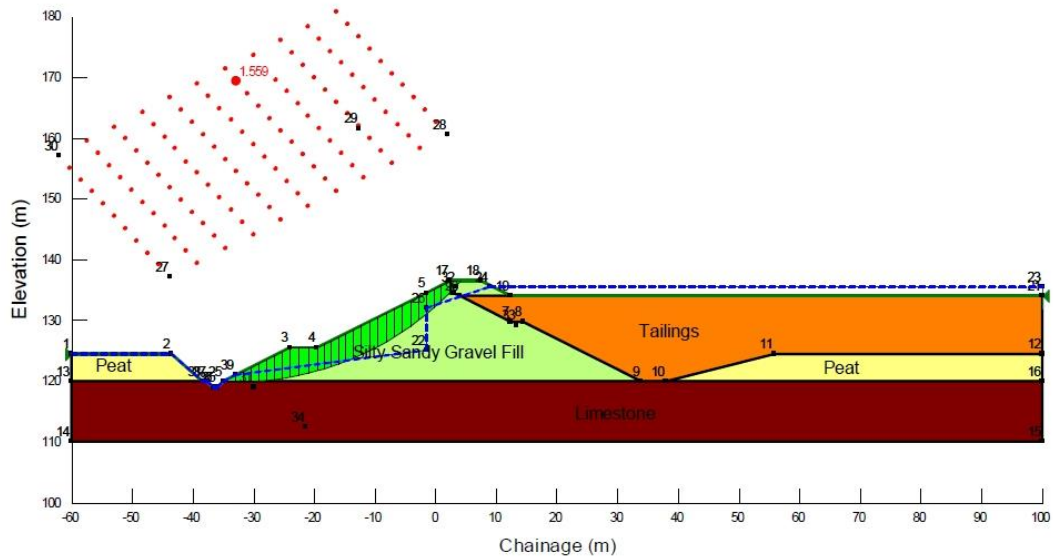
Figure 1: Operating Condition - Deep seated failure FOS

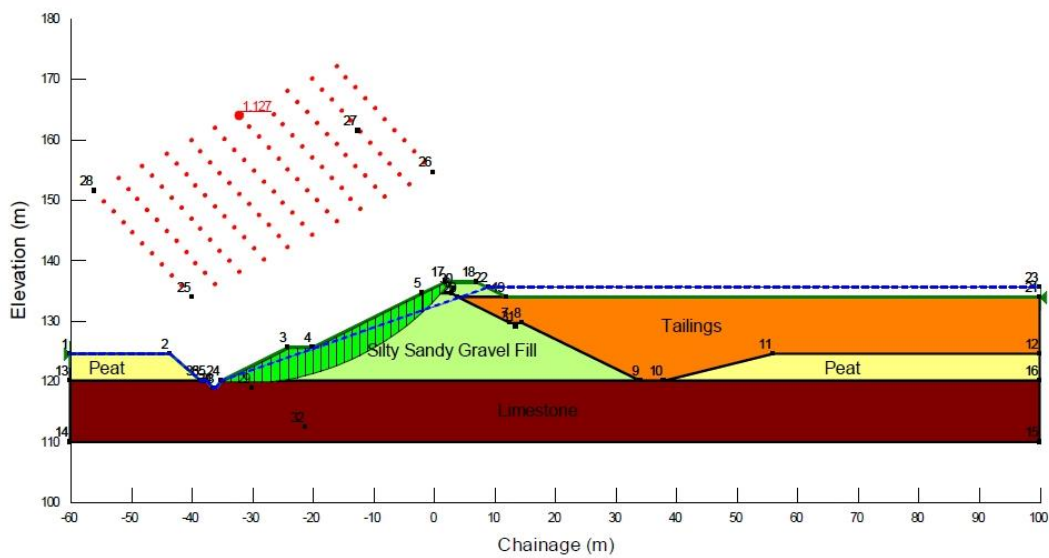
Figure 2: Critical Condition - Deep seated failure FOS
