**Proposed 110kV Substation and
Underground Grid Connection
at
Killoran, Co. Tipperary**

LISHEEN TMF ANNUAL REVIEW 2024

DATE: MARCH 2025

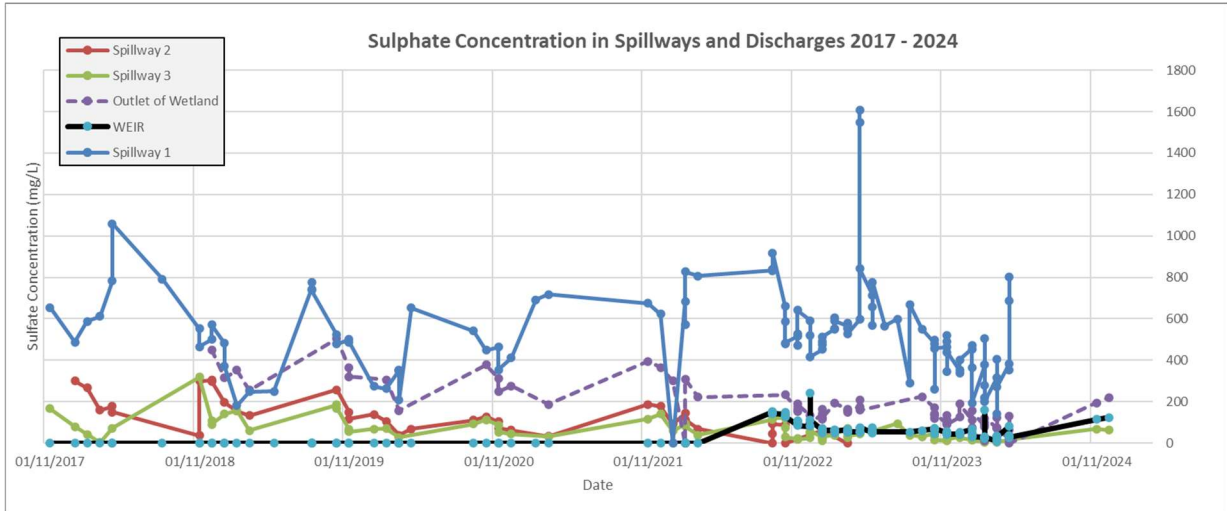
Figure 5-1 - Spillways & Discharges Sulphate Concentration (Licence Limit only relates to SW1)

Discharge at Spillway 1 (SW1) generally occurs between October and April. Figure 5-1 presents a summary of readings from 2017 to 2024, with sulphate concentration plotted on the y-axis in mg/L. A stop-start discharge pattern can be observed for Spillways and Discharges between 2017 and 2024, except for Spillway 1 during 2019, when pumping was continuous as part of seepage remediation works between CH2300 and CH2500.

Based on additional data from October 2024, this exceedance is attributed to the 'first flush' effect commonly observed at the beginning of discharge cycles.

- Spillway 1 continues to exhibit the highest sulphate, nickel, and zinc concentrations, indicating ongoing seepage influences.
- Spillway 3 continues to produce good quality water demonstrating the cap is working effectively. The water chemistry at the weir is comparable to the pre weir Spillway 2 water with the overall long term trend being downward, suggesting improved drainage control.
- The effectiveness of the weir in lowering water levels and reducing seepage will be assessed in a report towards the end of 2026.

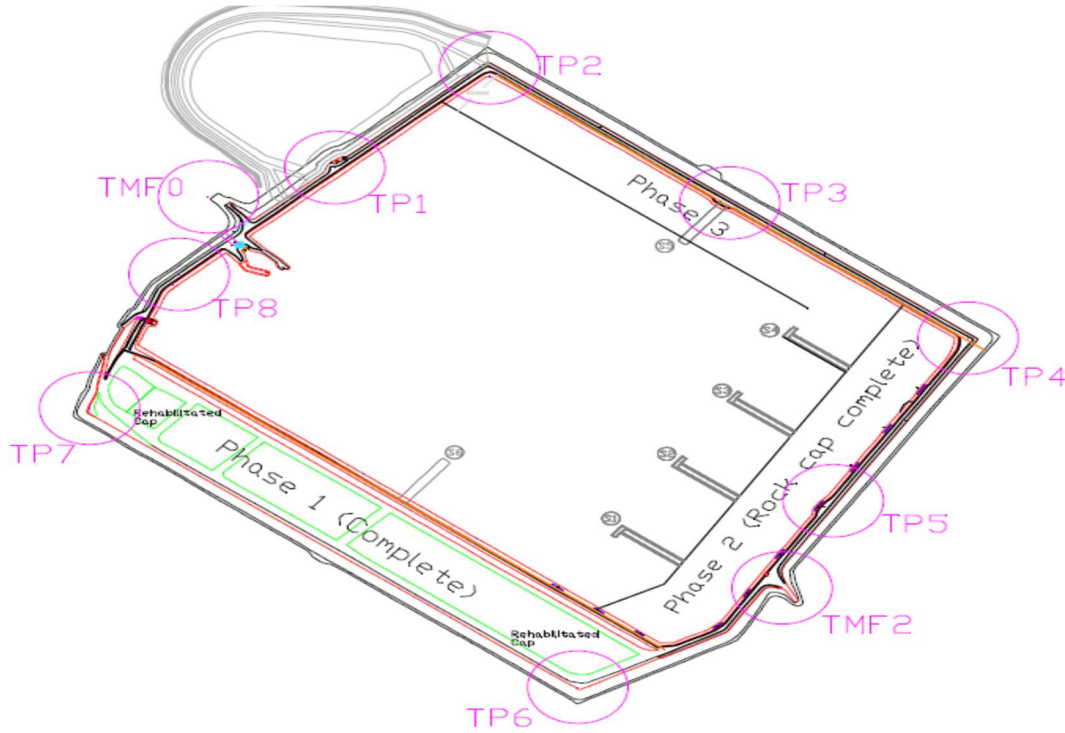
Figure 6-1 - Location Map for TMF Settlement Monitoring Points

Eight TMF settlement monitoring points were established in 2013 to measure the vertical movements of the dam. TMF0 and TMF2 are base stations fixed into the bedrock.

- It was identified in the 2022 annual report that 5 of the 8 stations were lost. These were replaced in Q3 2023 (Lisheen TMF: Survey Stations 41000013.TM80.B0).

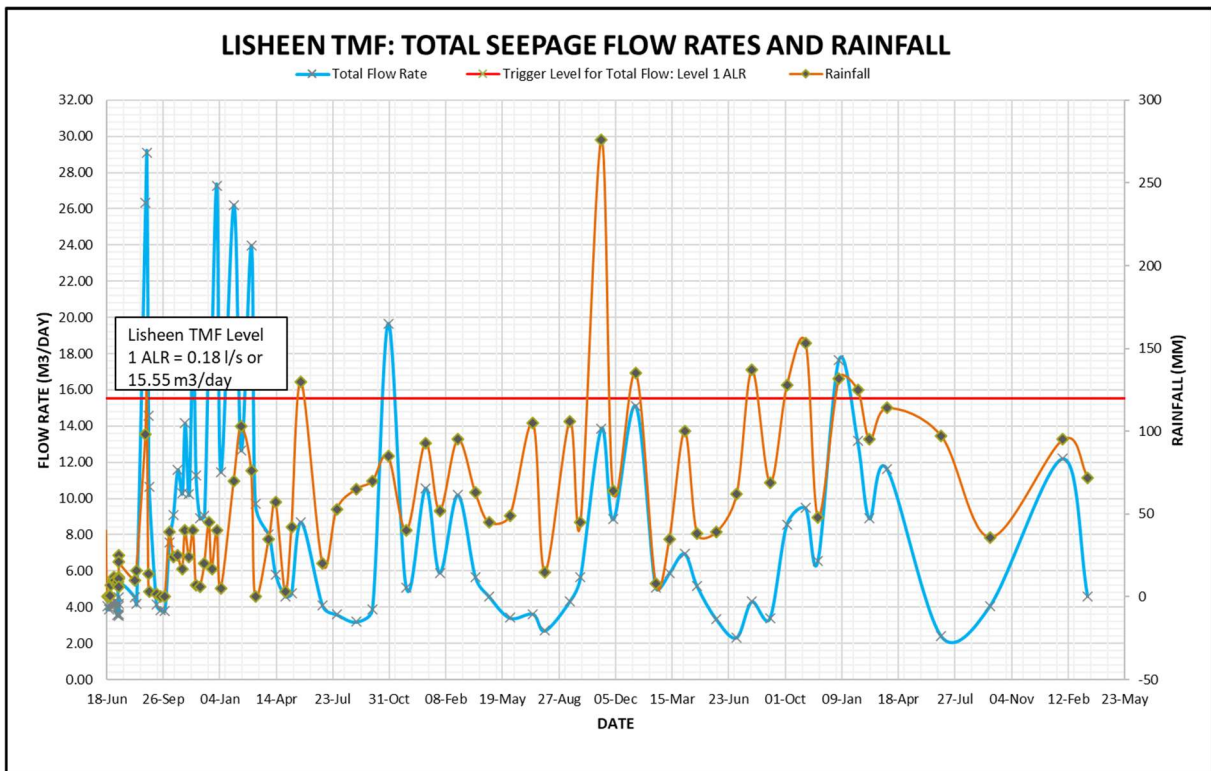
Figure 7-1 - Lisheen TMF - Seepage Flow Rates at UFD07, UFD14 and UFD16

For the reporting period from Q1 2024 through Q1 2025, seepage monitoring was performed using a combination of visual inspections, seepage heat mapping, flow rate measurements, and conductivity testing at the key upper finger drain (UFD) locations (UFD07, UFD14, and UFD16) (see Figure 7-1 to Figure 7-4). The objective is to ensure that the facility’s internal drainage system continues to operate within the acceptable Action Leakage Rate (ALR) thresholds.

- **Flow and Conductivity Measurements:**
Flow measurements at UFD07 and UFD16 consistently remained within the typical range of approximately 3–5 m³/day, while UFD14 recorded negligible flows under normal conditions. An isolated event in January 2024 registered a combined flow of 17.64 m³/day; however, corresponding conductivity readings remained below critical thresholds, indicating that the increased flow was due to rainwater dilution rather than an indication of increased leachate concentration.

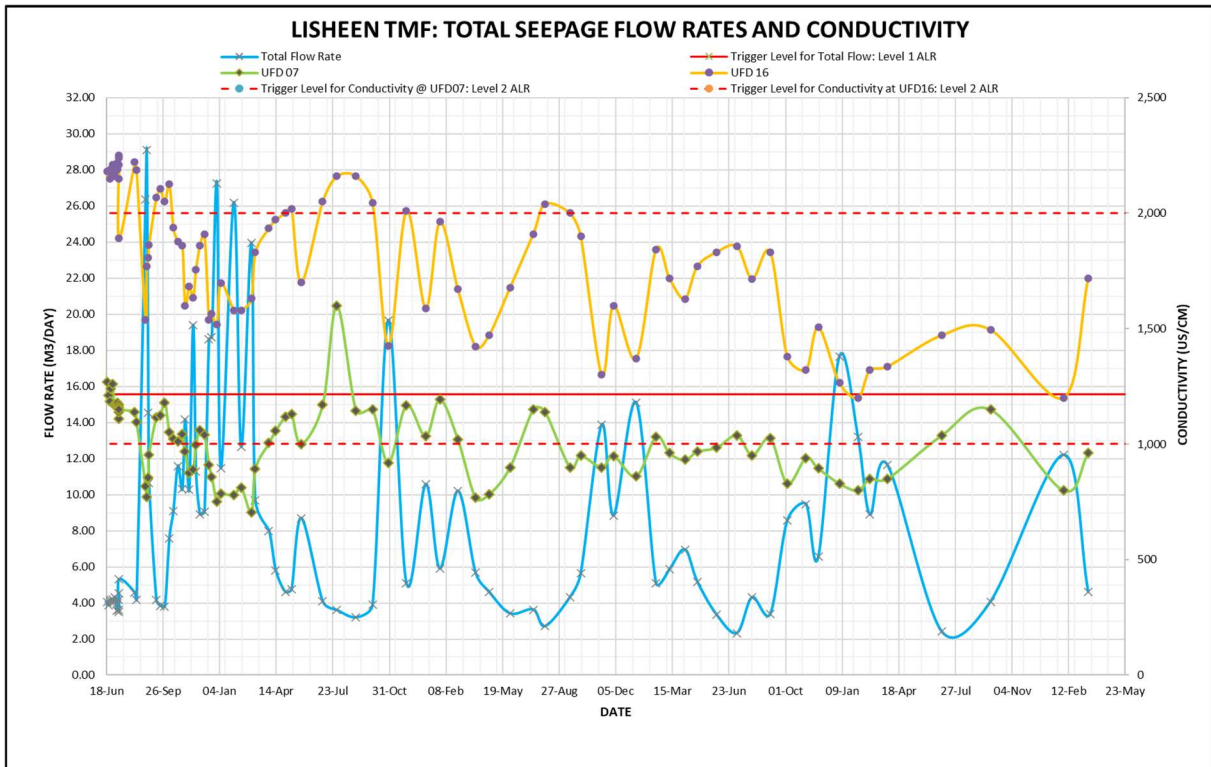
Figure 7-3 - Lisheen TMF - Conductivity Readings from UFDs and Weekly Rainfall

During the reporting period, all measured seepage rates and conductivity values remained within Level 1 conditions, confirming that the drainage system—including the chimney/finger drain network and the supplementary weir installed in August 2022—is performing effectively.
